Encountering Non-Compliant Installations of Communications Attachments in the Field

1. Scope

This work practice provides direction on the steps to take when non-compliant installations of communications attachments are encountered in the field.

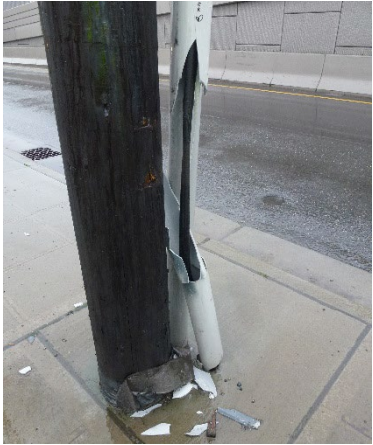
Steps	Description	Example
Step 1	Take a close-up photo of the non-compliant attachment. The example shown is of a broken riser base.

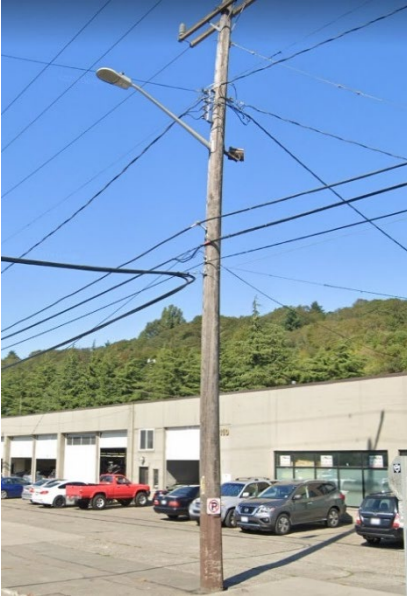
Step 2	Take a full-length photo of the pole

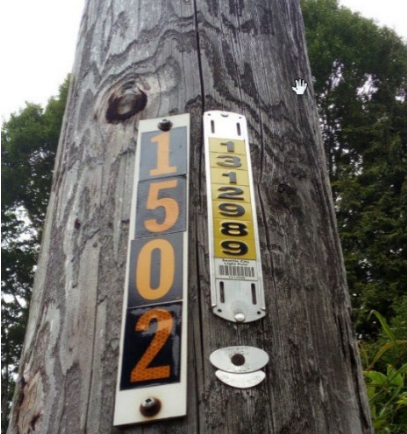
Step 3	Take a photo of the pole tag.

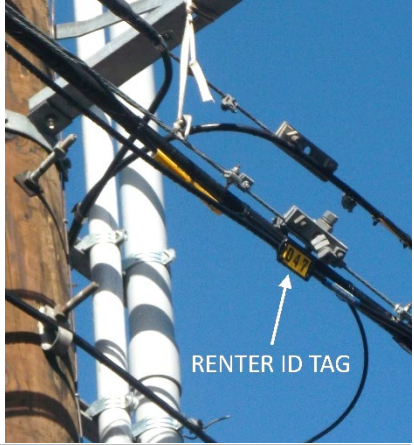
Steps	Description	Example
Step 4	Take a close-up photo of a 3-digit renter identification (ID) tag. ID tags are required to be applied by the organization/renter of such equipment at every location to which the equipment is attached including all cables, risers, handholes, equipment boxes, etc. See SCL 0093.12.
