## Overhead Transformer Lightning Strike Procedure

### 1. Scope

This standard covers the decisions operations personnel make when an overhead transformer installed in the field is out of service and a lightning strike is the suspected cause.

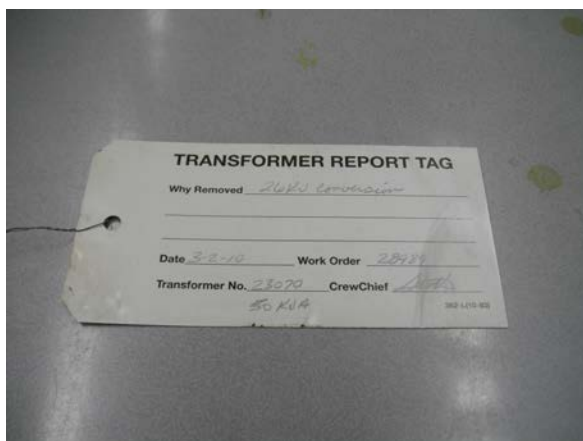
The suspect transformer shall be taken to the Transformer Repair Shop at the South Service Center for testing. The Crew Chief shall fill out and attach the Transformer Report Tag describing why the unit was removed, the date, and other relevant information. See Figure 4.2.

**Figure 4.2. Transformer Report Tag**
